==== Shimadzu LabSolutions Analysis Report ====

Sample Name : 1433497-19-8 Sample ID :
 Vial# : 1-26 Injection Volume : 1 uL
 Date Acquired : 2018/6/22 9:31:43 Acquired by : System Administrator
 Date Processed : 2018/6/22 10:02:14 Modified by : System Administrator
 Data Filename : D:\DATA\20180621\1433497-19-8-3.lcd
 Method Filename : C:\LabSolutions\Data\Project1\test-001.lcm
 Batch Filename : D:\DATA\20180621\20180621.lcb

==== Shimadzu LabSolutions 分析报告 ====

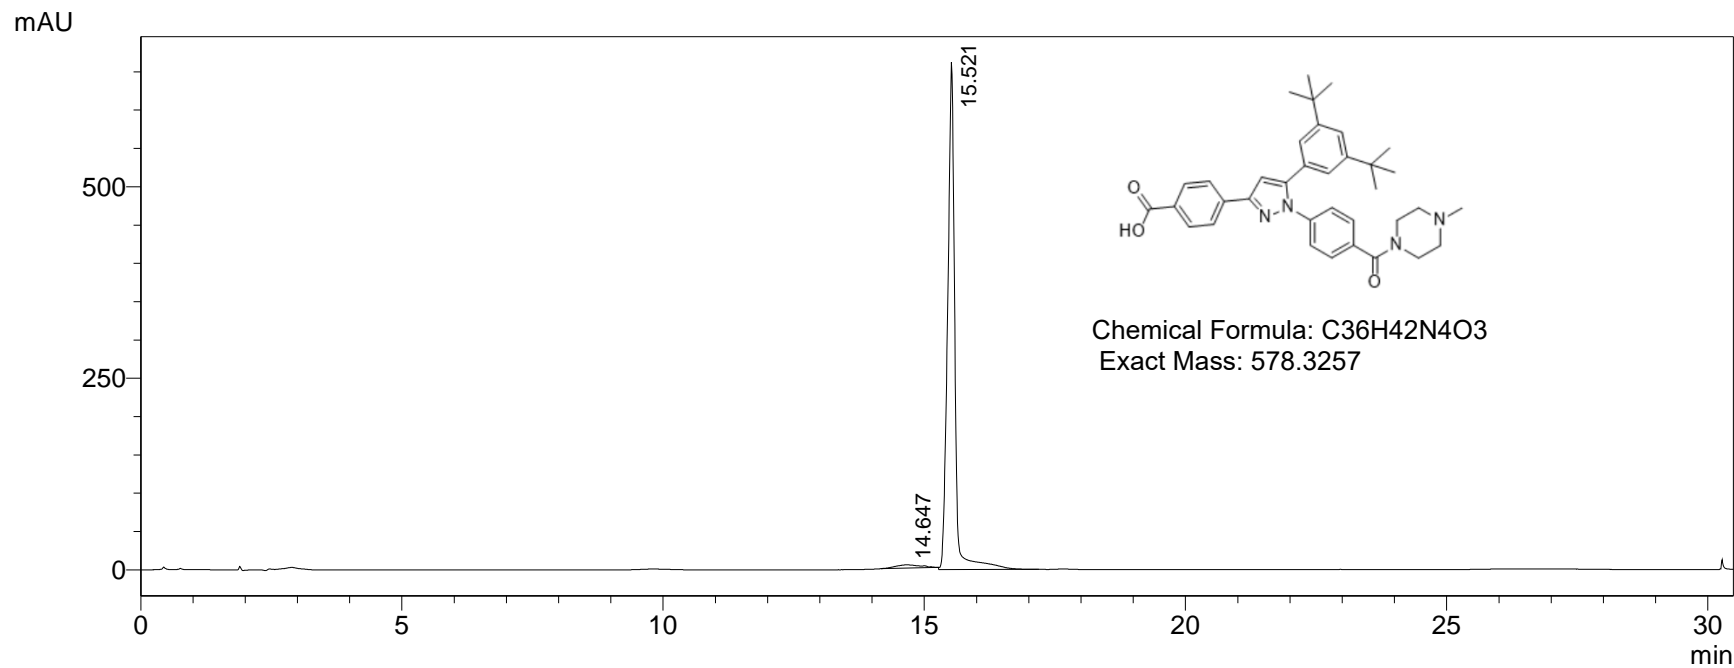
PDA Ch1 254nm

Peak#	Ret. Time	Area	Area%	Height	Height%	Name
1	14.647	144528	2.214	4430	0.665	
2	15.521	6384289	97.786	662093	99.335	
总计		6528817	100.000	666523	100.000

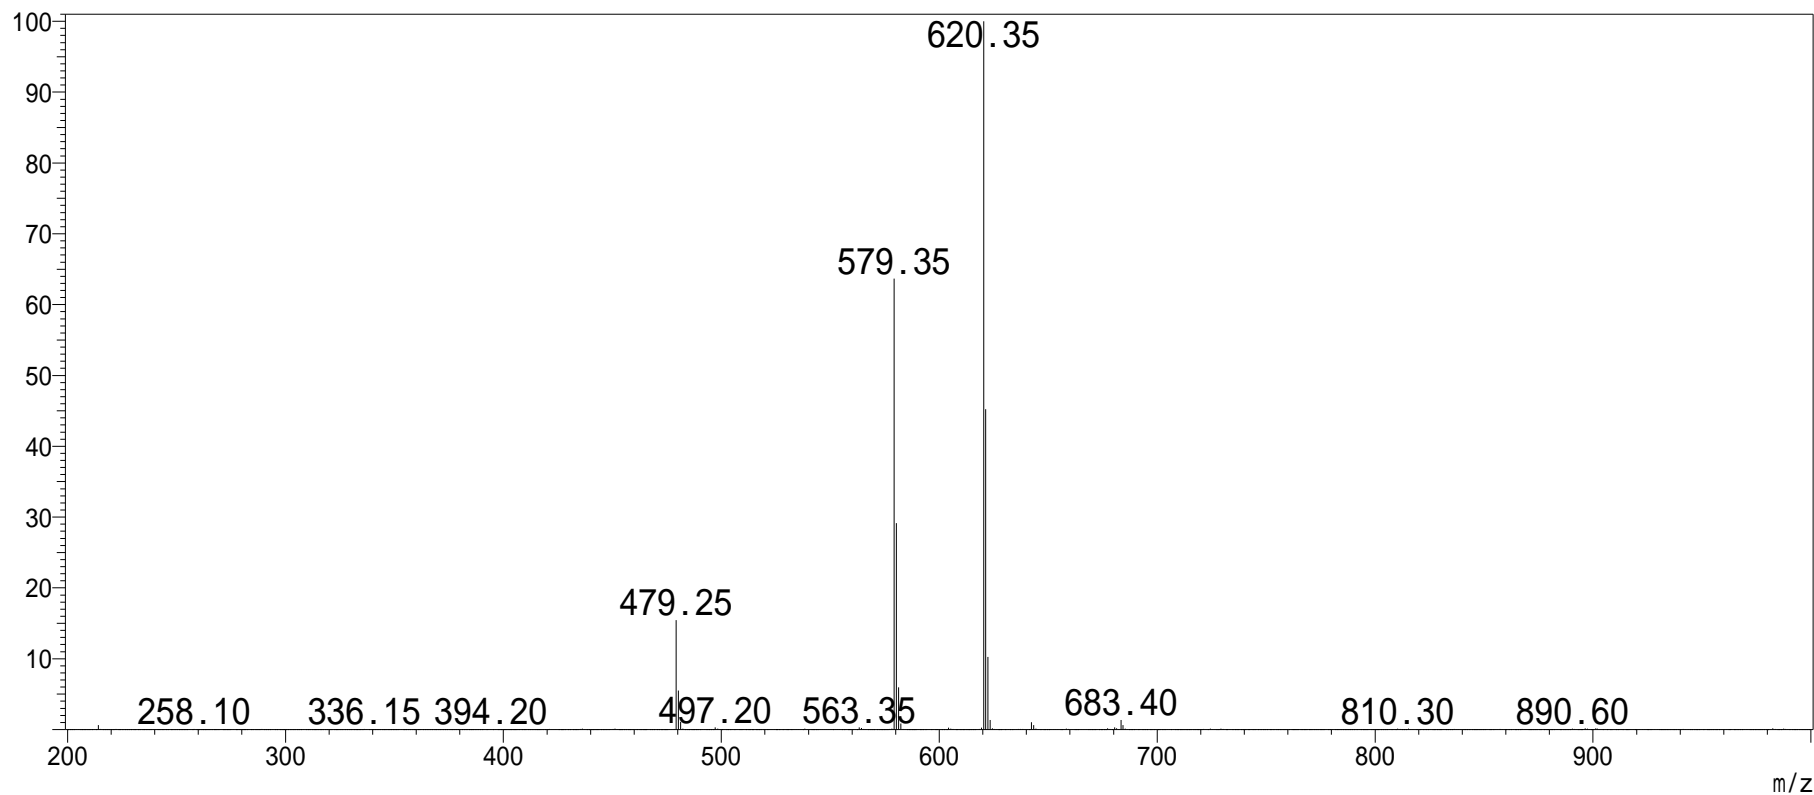
#: 1 保留时间: 15.600(扫描#: 937)

峰数: 891

质谱: 单图 15.600(937) 基峰: 620.35(5716179)

背景: 无 段 1 - 事件 1

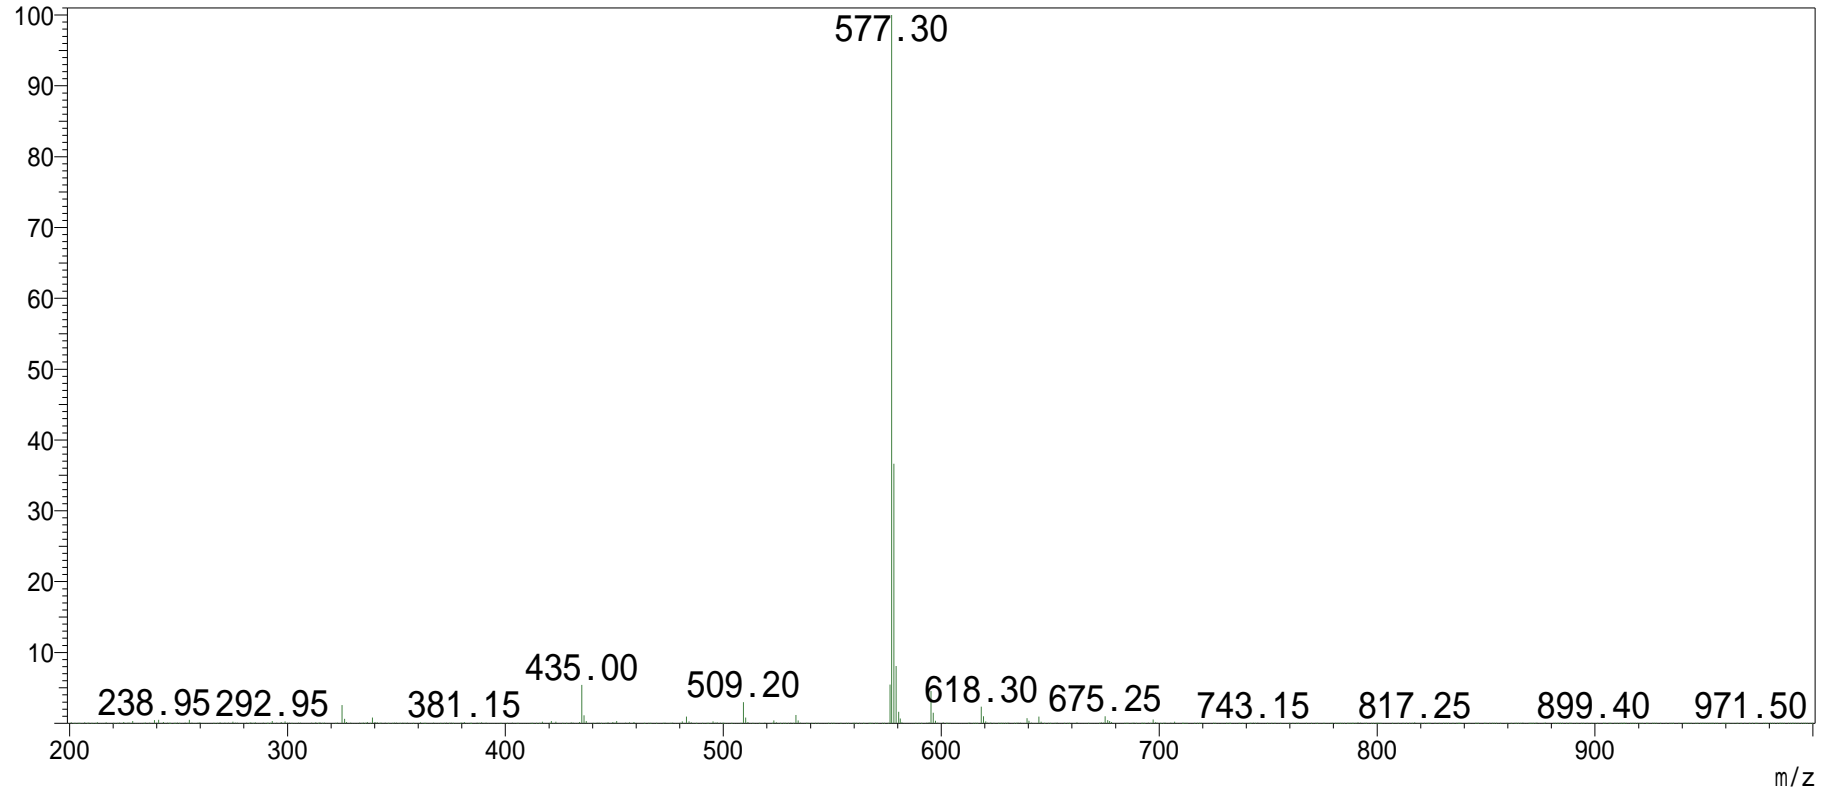
#:2 保留时间:15.616(扫描#:938)

峰数:862

质谱:单图 15.616(938) 基峰:577.30(2872761)

背景:无 段 1 - 事件 2
