# ==== Shimadzu LabSolutions Analysis Report =====

Sample Name : 1437321-24-8 CEP-40783  
 Vial# : 1-15  
 Date Acquired : 2018/6/25 14:02:45  
 Date Processed : 2018/6/25 14:25:53  
 Data Filename : D:\DATA\20180625\1437321-24-8 CEP-40783.lcd  
 Method Filename : C:\LabSolutions\Data\Project1\test-001.lcm  
 Batch Filename : D:\DATA\20180625\20180625.lcb

==== Shimadzu LabSolutions 分析报告 ====

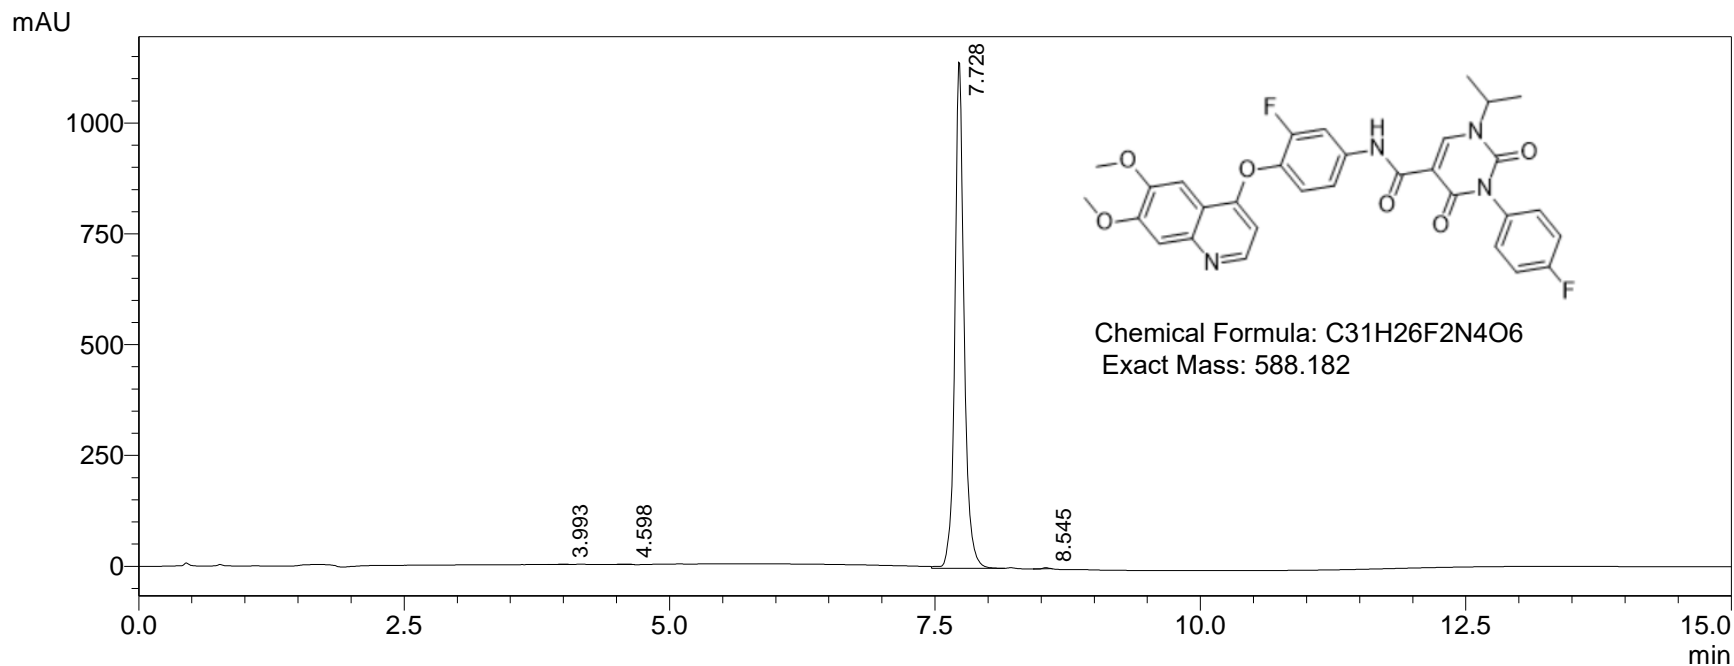
PDA Ch2 280nm

Peak#	Ret. Time	Area	Area%	Height	Height%	Name
1	3.993	3067	0.044	519	0.045	
2	4.598	5038	0.073	1020	0.089	
3	7.728	6924762	99.760	1141681	99.638	
4	8.545	8565	0.123	2612	0.228	
总计		6941432	100.000	1145831	100.000

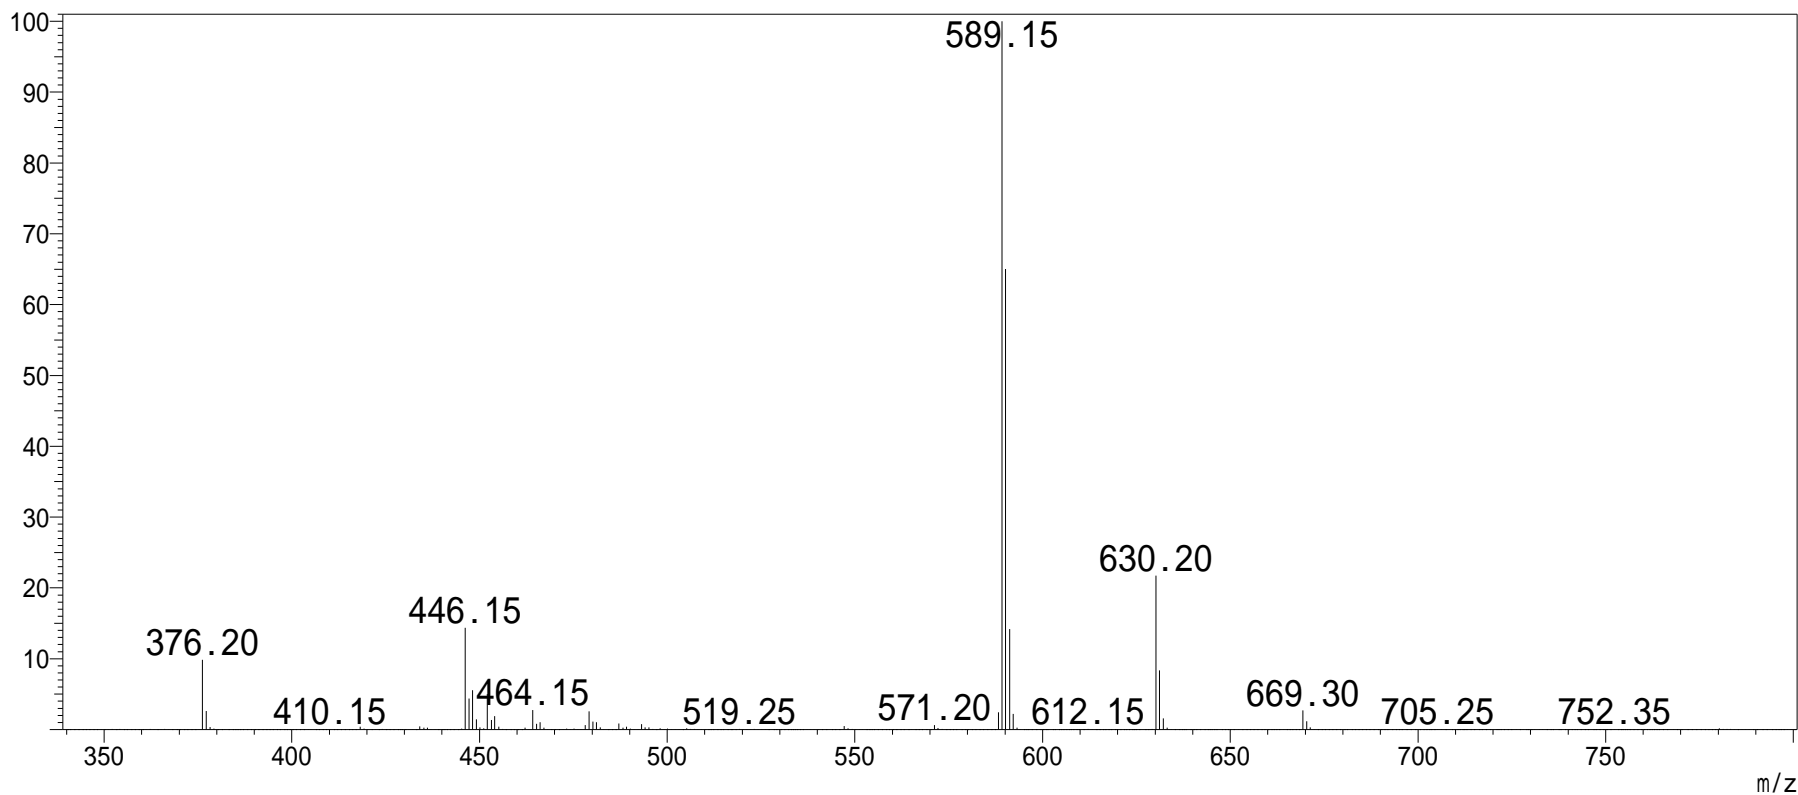
#: 1 保留时间: 7.733(扫描#: 465)

峰数: 488

质谱: 单图 7.733(465) 基峰: 589.15(11407682)

背景: 无 段 1 - 事件 1

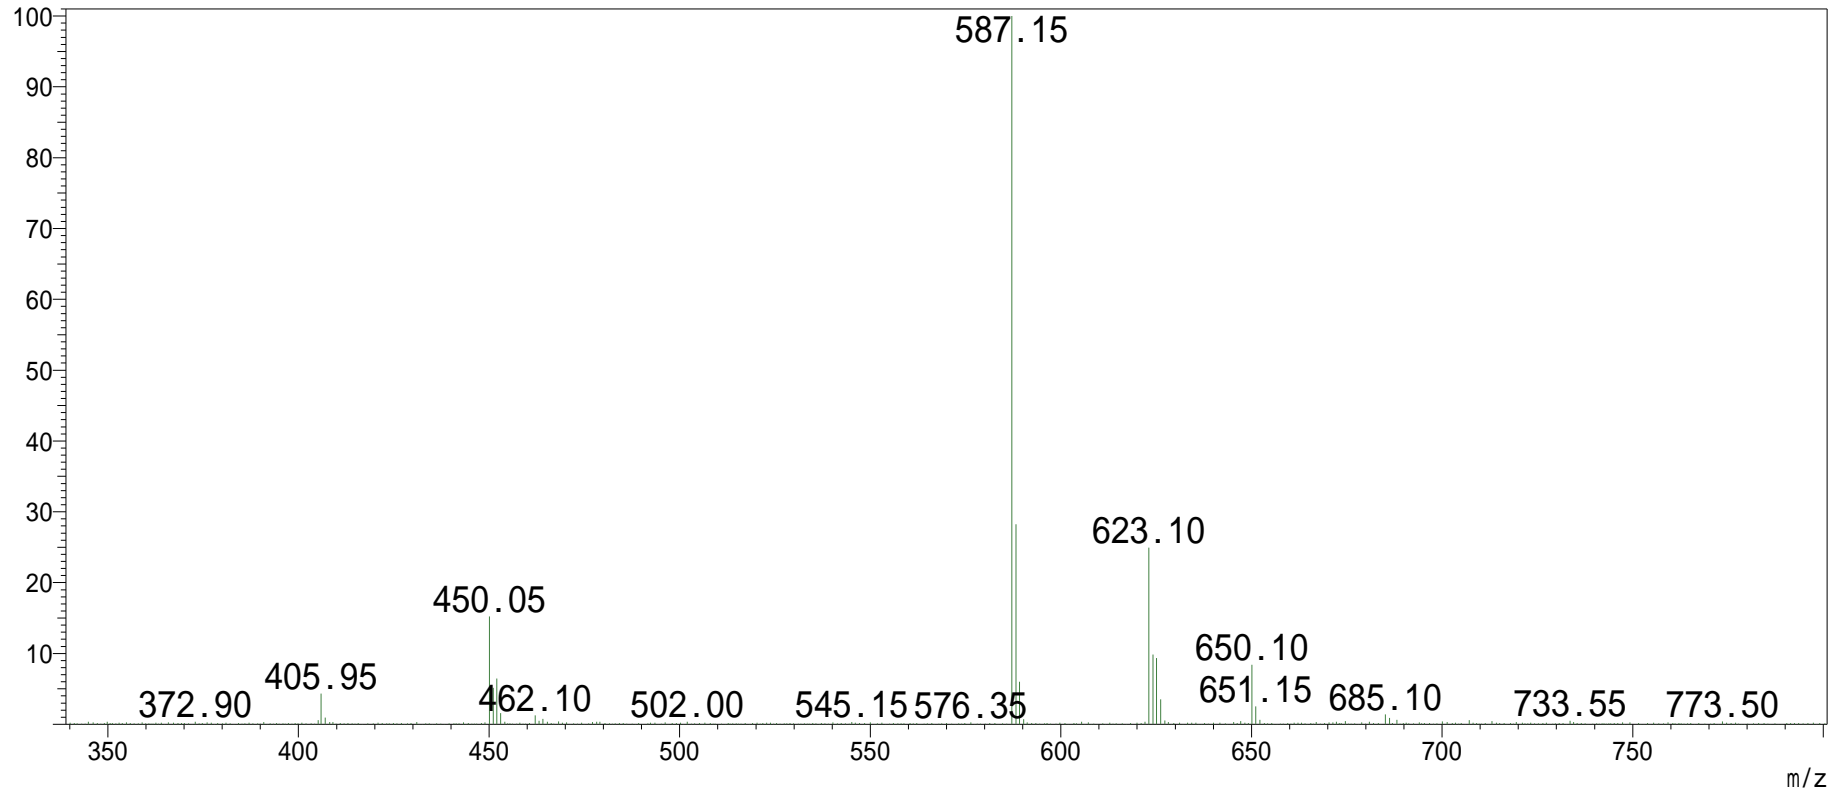
#:2 保留时间:7.749(扫描#:466)

峰数:482

质谱:单图 7.749(466) 基峰:587.15(453495)

背景:无 段 1 - 事件 2
