Name: SCH-58261
CAS#: 160098-96-4

==== Shimadzu LabSolutions Analysis Report ====

Sample Name : SCH58261
 Vial# : 1-18
 Date Acquired : 2018/8/24 16:28:13
 Date Processed : 2018/8/24 16:49:43
 Data Filename : D:\DATA\20180824\SCH58261_001.lcd
 Method Filename : C:\LabSolutions\Data\Project1\test-001.lcm
 Batch Filename : D:\DATA\20180824\20180824.lcb

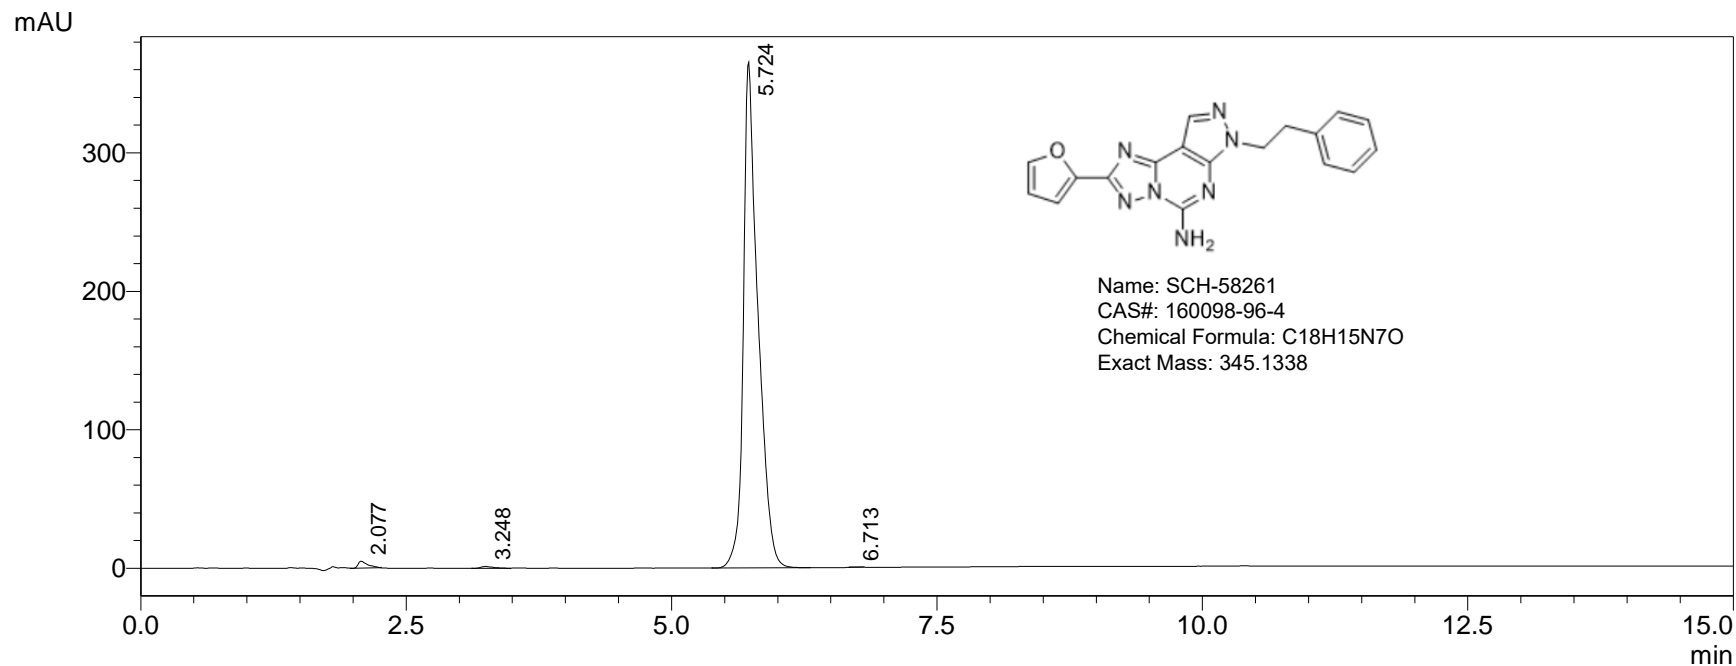
PDA Ch1 254nm

Peak#	Ret. Time	Area	Area%	Height	Height%	Name
1	2.077	30653	0.866	4974	1.338	
2	3.248	11920	0.337	1355	0.365	
3	5.724	3495416	98.762	365112	98.229	
4	6.713	1231	0.035	255	0.069	
总计		3539220	100.000	371697	100.000

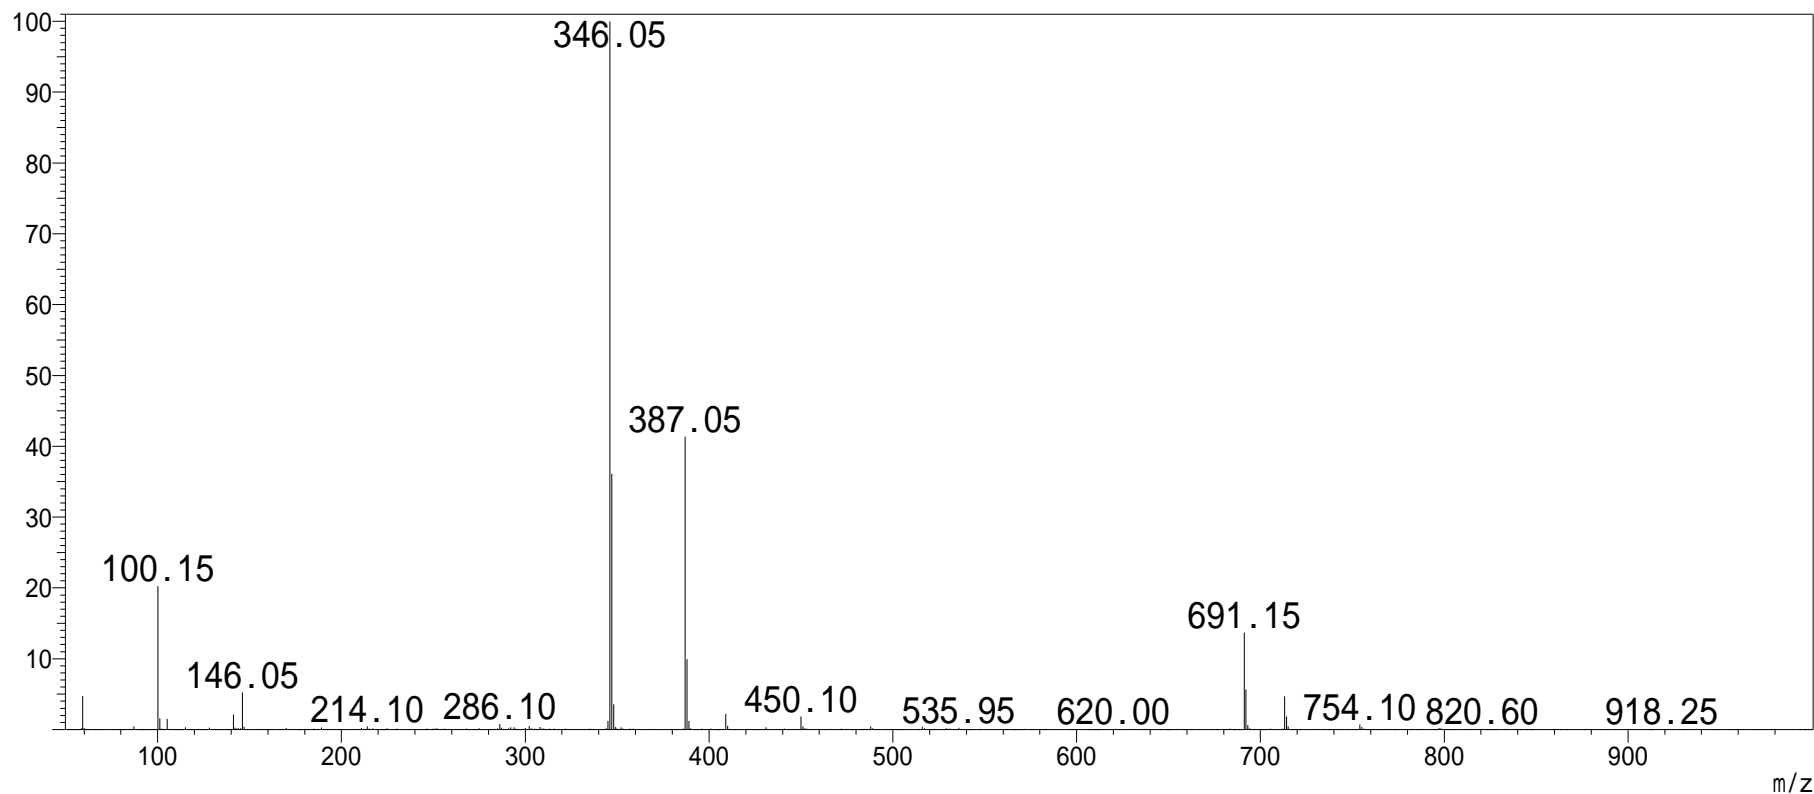
#: 1 保留时间: 5.700(扫描#: 343)

峰数: 1032

质谱: 单图 5.700(343) 基峰: 346.05(8054919)

背景: 无 段 1 - 事件 1

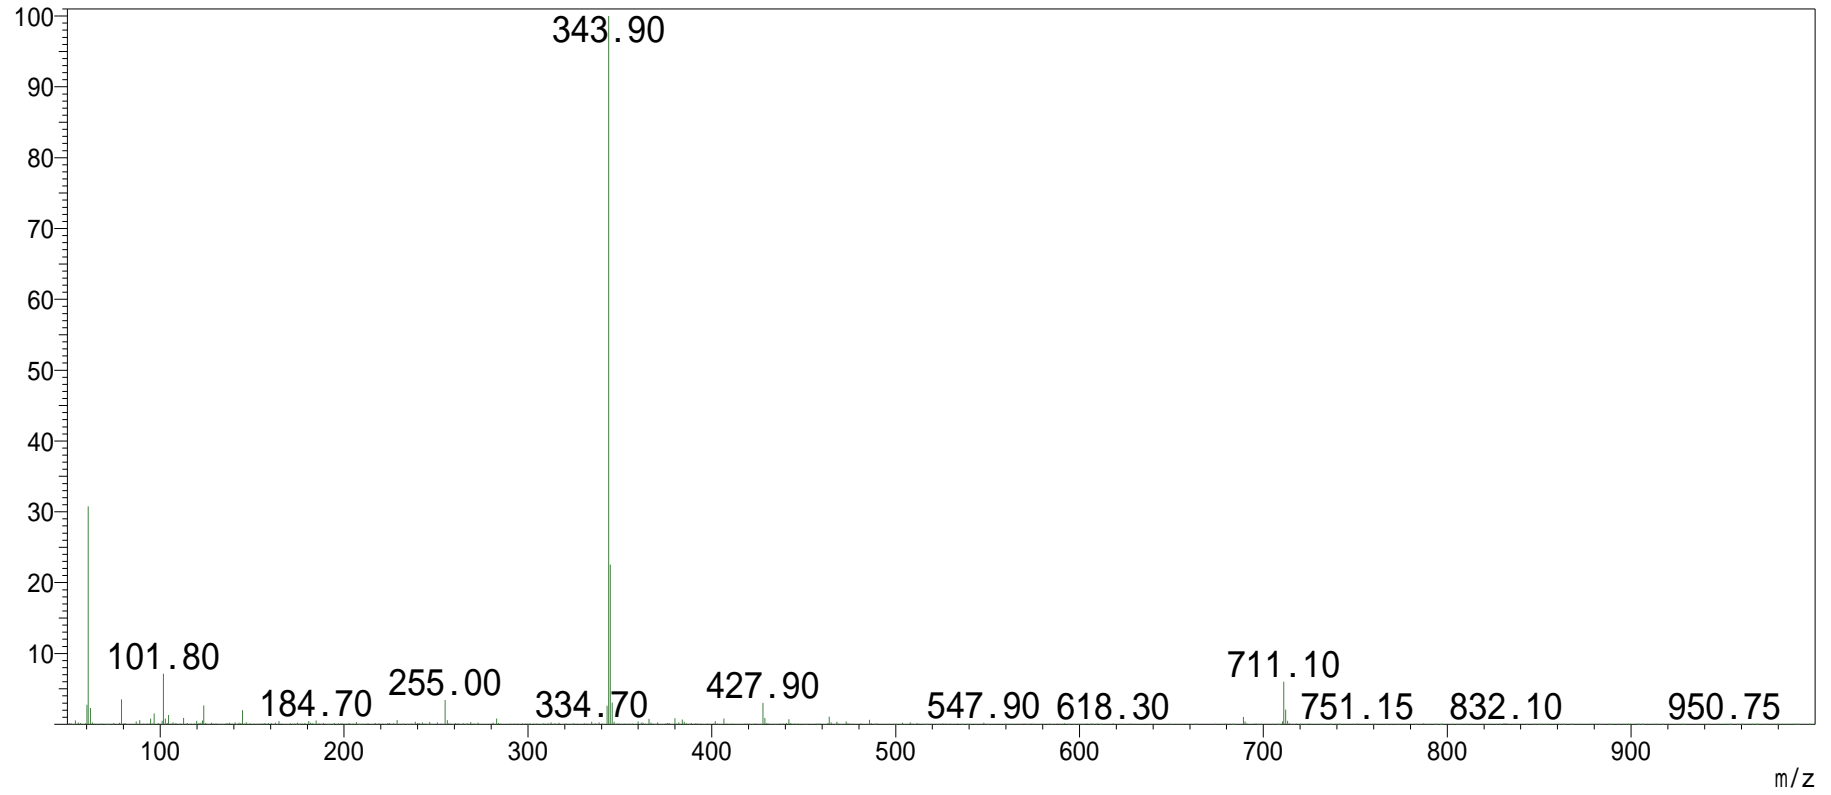
#:2 保留时间:5.716(扫描#:344)

峰数:1050

质谱:单图 5.716(344) 基峰:343.90(2487910)

背景:无 段 1 - 事件 2
