==== Shimadzu LabSolutions Analysis Report ====

Sample Name : AZD7648
 Vial# : 1-10
 Date Acquired : 2019/6/17 14:29:10
 Date Processed : 2019/6/17 14:41:56
 Data Filename : D:\DATA\20190617\AZD7648.lcd
 Method Filename : C:\LabSolutions\Data\Project1\ESI.lcm
 Batch Filename : D:\DATA\20190617\20190617.lcb

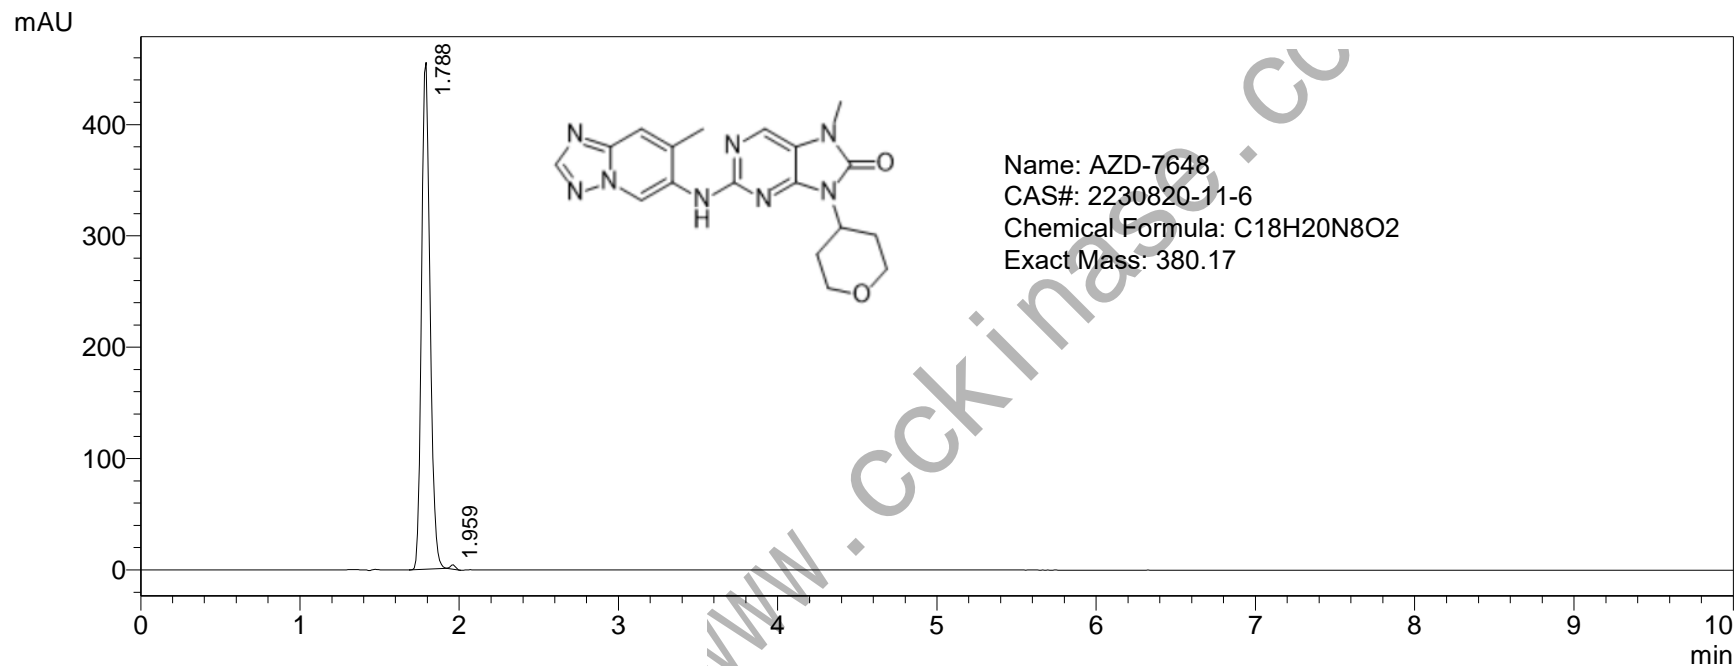
PDA Ch1 254nm

Peak#	Ret. Time	Height	Height%	Area	Area%	Name
1	1.788	455269	99.162	1682574	99.527	
2	1.959	3849	0.838	7992	0.473	
总计		459118	100.000	1690565	100.000

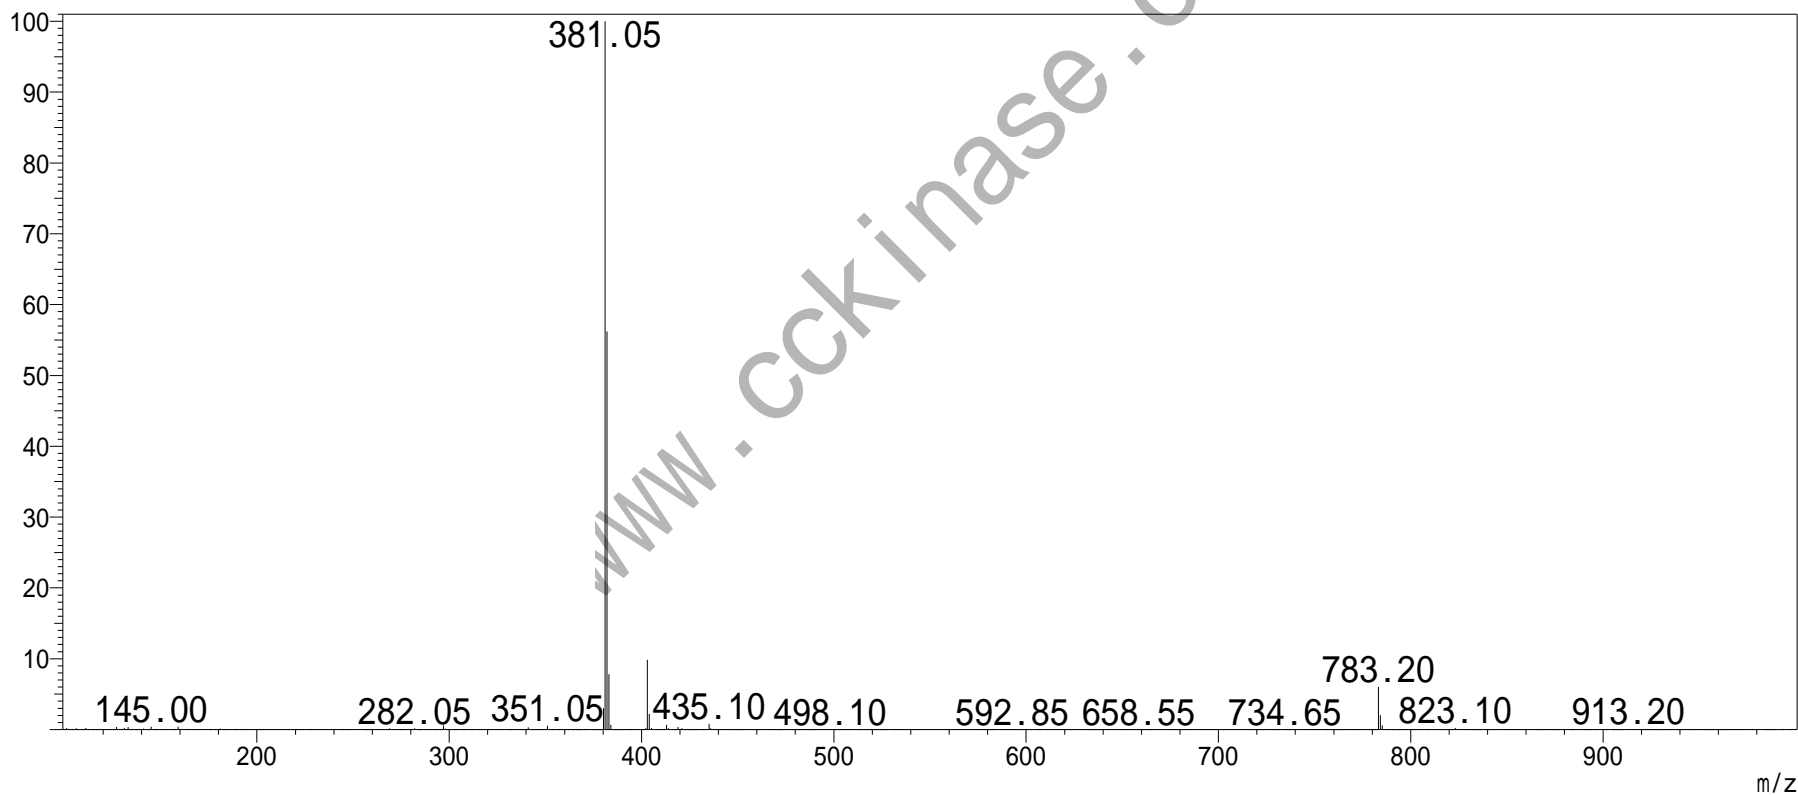
#: 1 保留时间: 1.867(扫描#: 113)

质谱: 单图 1.867(113) 基峰: 381.05(10970739)

背景: 无 段 1 - 事件 1
