==== Shimadzu LabSolutions Analysis Report ====

Sample Name : DWK-1339
 Vial# : 1-9
 Date Acquired : 2019/6/17 14:12:01
 Date Processed : 2019/6/17 14:28:11
 Data Filename : D:\DATA\20190617\DWK-1339.lcd
 Method Filename : C:\LabSolutions\Data\Project1\ESI.lcm
 Batch Filename : D:\DATA\20190617\20190617.lcb

==== Shimadzu LabSolutions 分析报告 ====

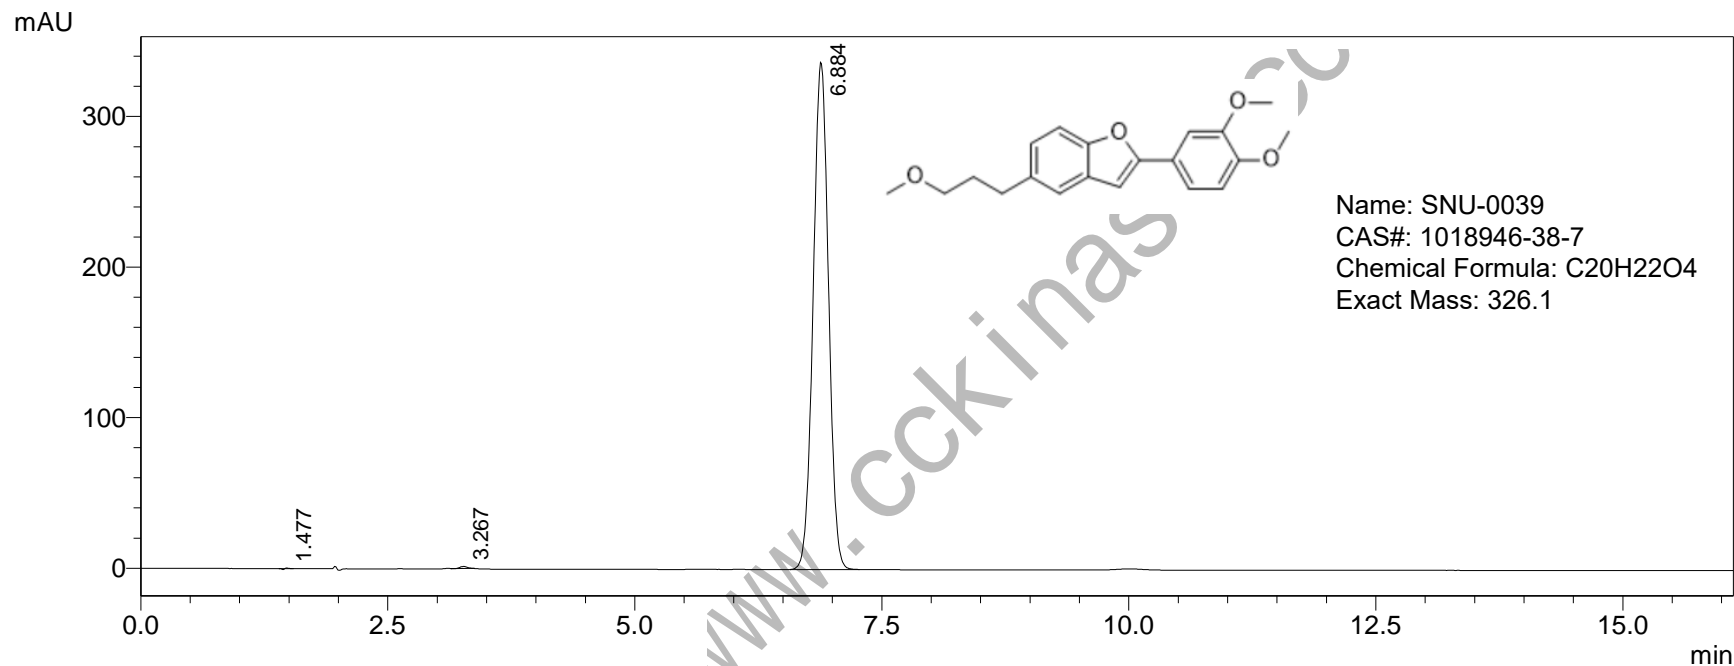
PDA Ch1 290nm

Peak#	Ret. Time	Height	Height%	Area	Area%	Name
1	1.477	470	0.139	36	0.001	
2	3.267	1353	0.400	7008	0.192	
3	6.884	336884	99.462	3639149	99.807	
总计		338707	100.000	3646193	100.000

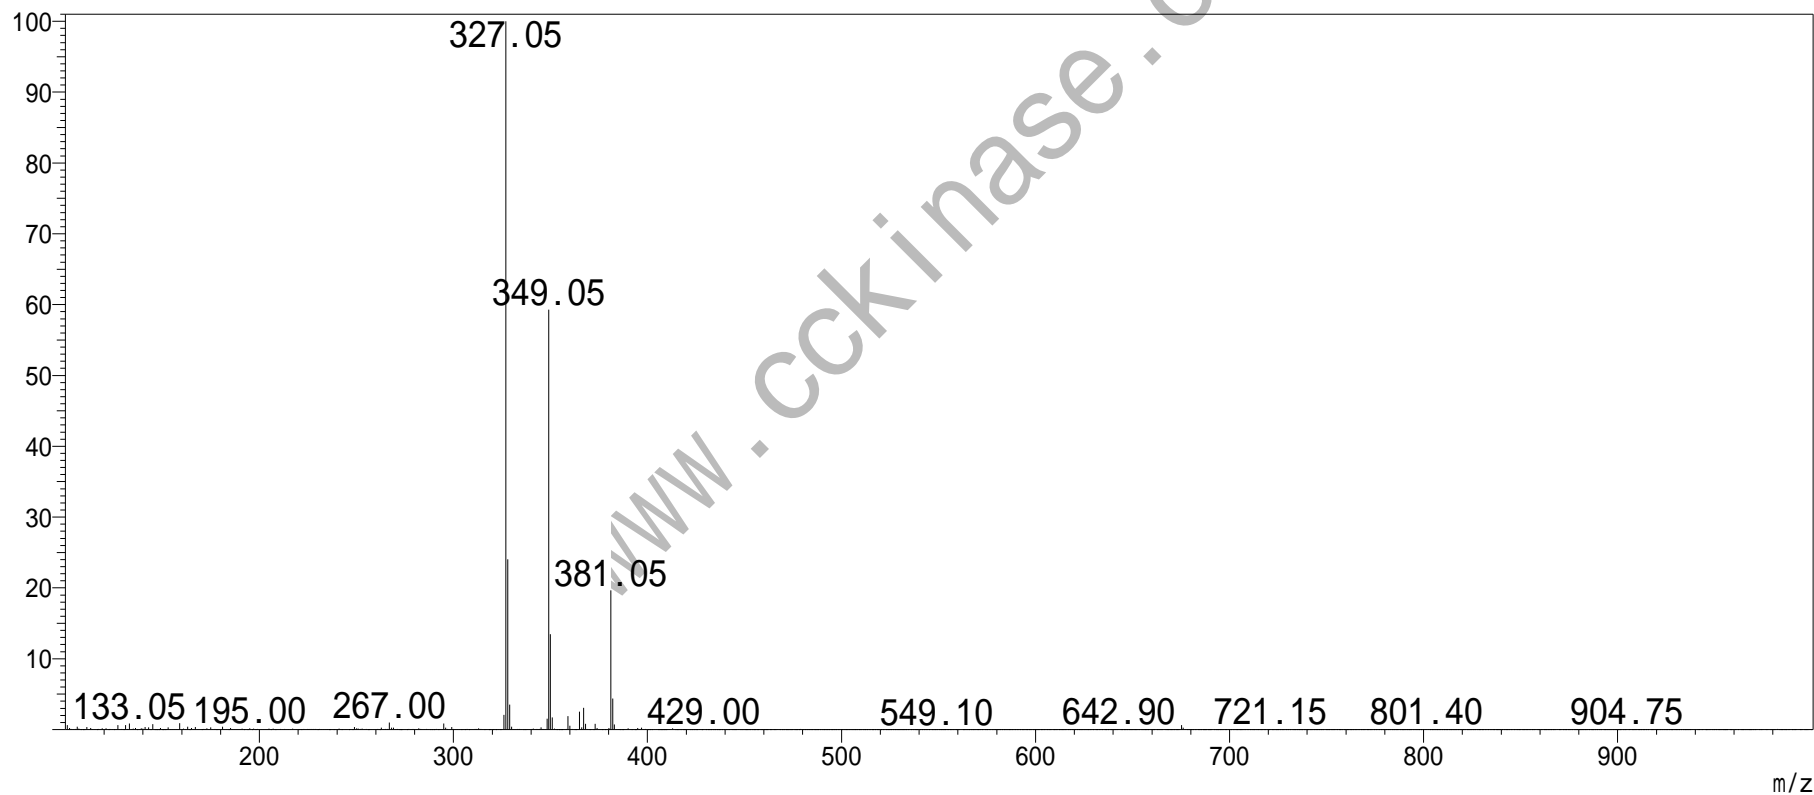
#: 1 保留时间: 6.967(扫描#: 419)

峰数: 979

质谱: 单图 6.967(419) 基峰: 327.05(7277626)

背景: 无 段 1 - 事件 1
